PASSAIC RIVER BASIN
DARLINGTON BROOK, BERGEN COUNTY
NEW JERSEY

DARLINGTON LAKE DAM

NJ 00230

PHASE 1 INSPECTION REPORT
NATIONAL DAM SAFETY PROGRAM

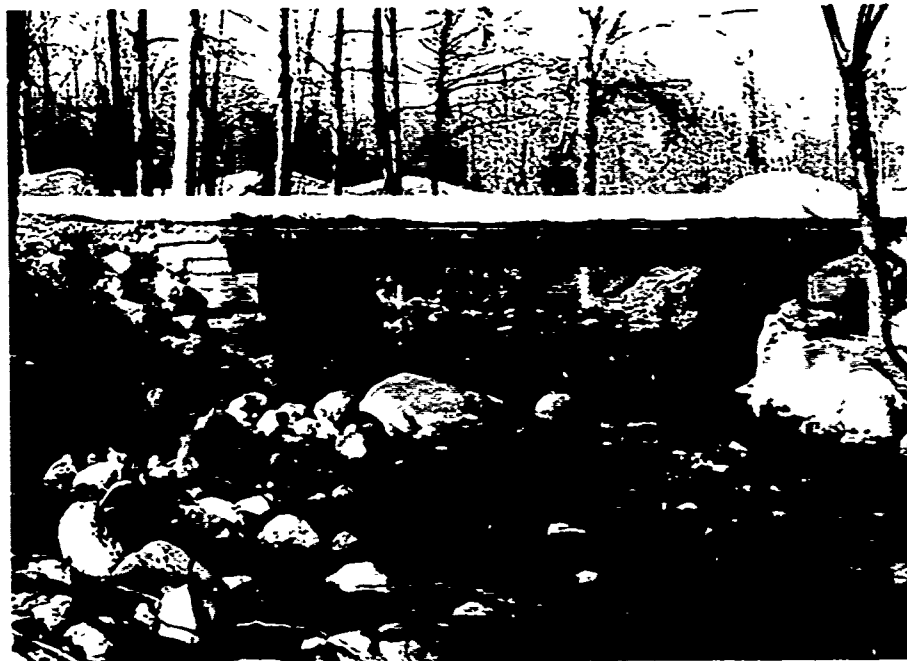
Photo 4 - View of downstream channel, also known as Darlington Brook, from upstream at vicinity of the 60 inch R.C.P. mentioned in Photo 3. Bridge is approximately 50 feet from the R.C.P. The Parking Area is out of photo on viewer's right. (Photo taken on February 8, 1980).
